# Consultant's new galloping-conductor study finds 15-yr old device still offers best control

LEXINGTON, MA—A 15-year old device to reduce the adverse effects of galloping conductors still is the best, most economical solution to the problem, says a consulting engineer located here.

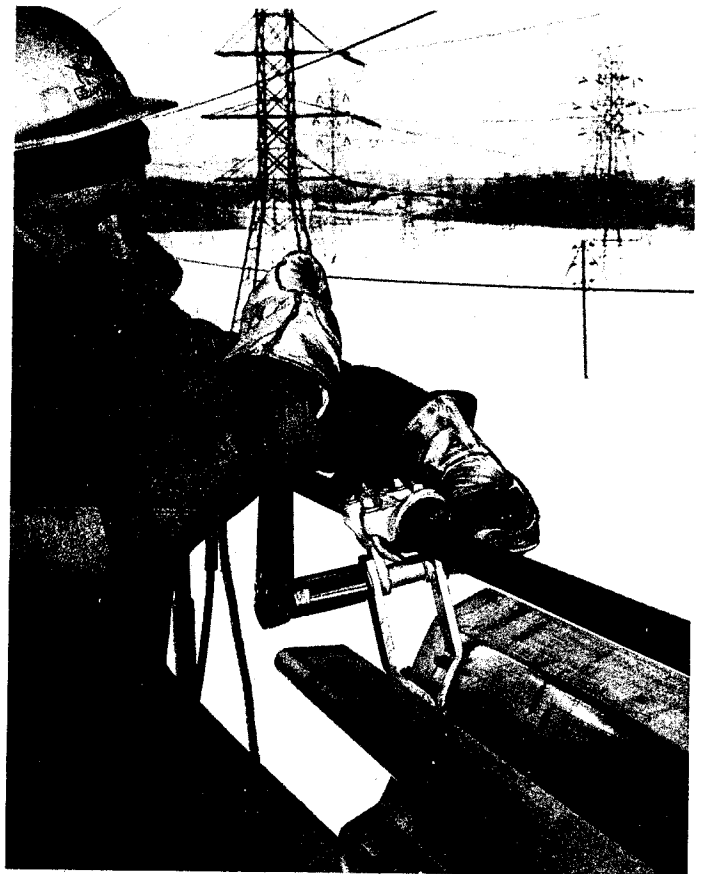
Crew member is shown installing Windamper anti-galloping device on line. Study indicates the 15-year old device still offers the most economic protection.

At Niagara Mohawk Power Corp., after initial observations of test lines in 1968 indicated that galloping on Windamper-protected transmission lines was held to a magnitude of one foot, the utility has continued to order and install the units. Some 1000 units are now in use on NMP's lines. RCA's investigation indicates that gallop-induced line tripping has been totally eliminated on lines equipped with the devices and operating personnel consistently affirm the effectiveness.
